Technical Report REMR-CS-61
June 1999

Repair, Evaluation, Maintenance, and Rehabilitation Research Program

An Evaluation of Equipment and Procedures for Tensile Bond Testing of Concrete Repairs

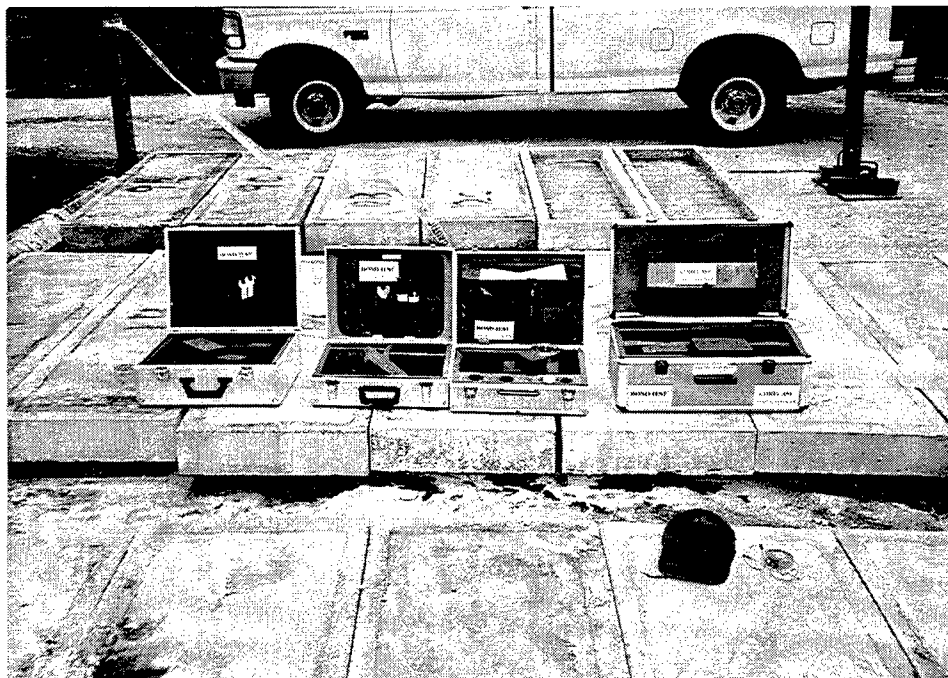
Figure 3. Germann Instruments testing equipment at the jobsite (Florida)

The equipment consists of four kits: preparation kit, pull machine kit, corecase kit, and DSV kit (Figure 3).

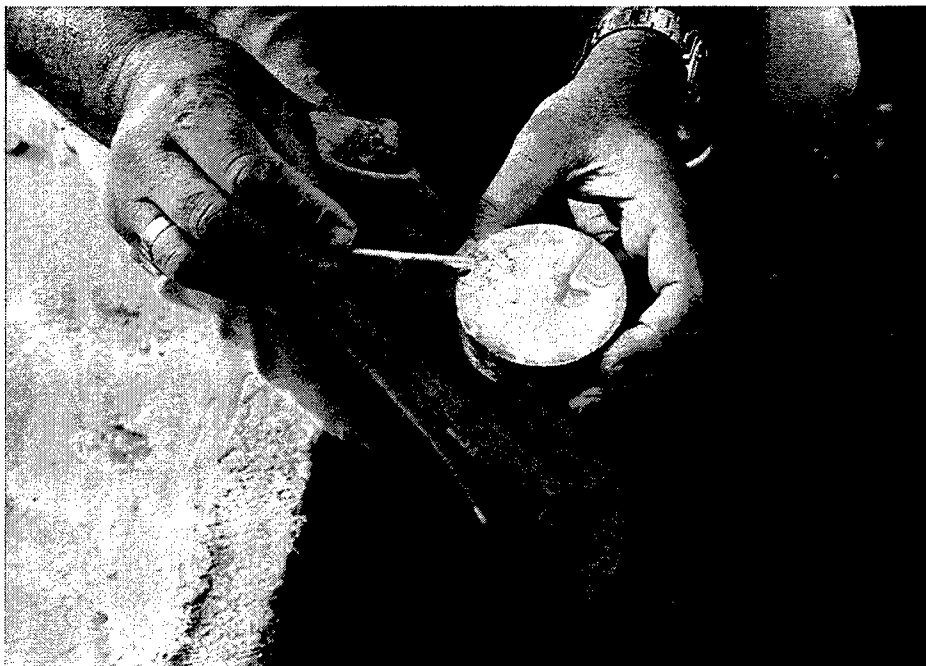
Figure 7. Application of adhesive

- b. A 75-mm (3-in.) diameter and 30-mm (1.2-in.) thick steel disc is applied with special fastsetting glue to the repair surface inside the suction plate by means of the centering plate and pressed firmly against the surface with the adjustable pliers (Figures 7 and 8).

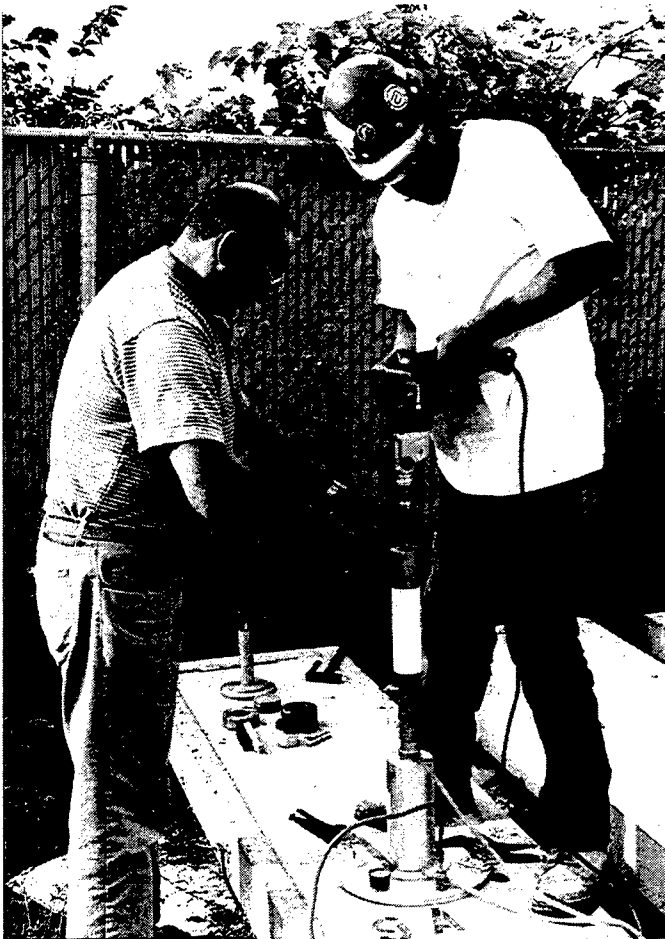
Figure 9. Core drilling

- c. The glue usually hardens in 2 to 5 min depending on ambient temperature.
- d. The corecase assembly is fitted around the disc and attached to the suction plate. Drilling takes place to the required depth (Figures 9 and 10).

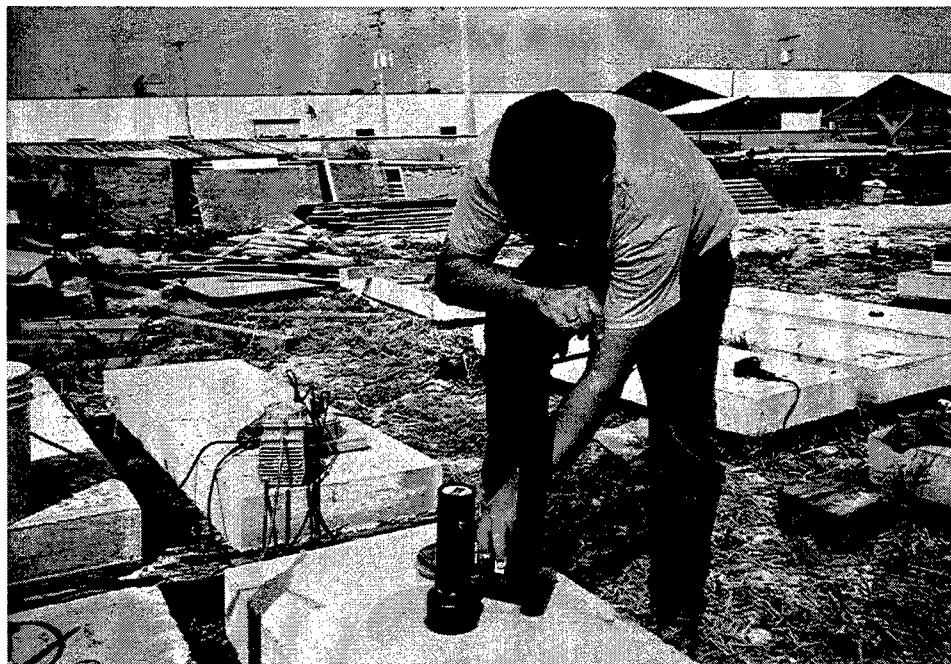
Figure 11. Germann Instruments pull-off testing

- e. The bond-test hydraulic apparatus is connected to the steel disc resting against the counterpressure frame and loaded by hand (Figure 11). Loading takes place with a constant loading rate to rupture the drilled core at the weakest location.

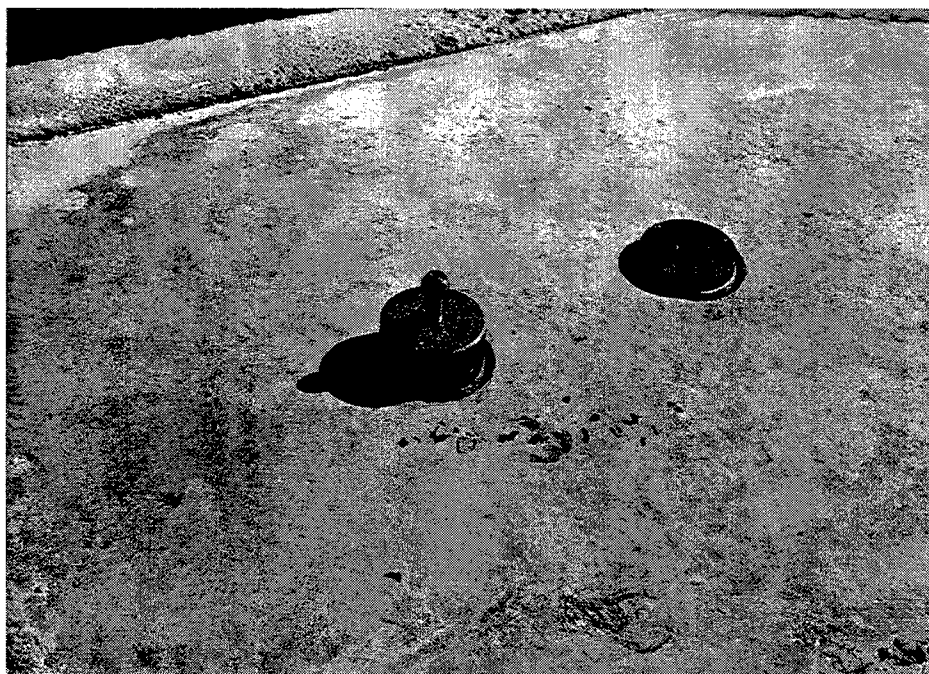
Figure 14. Partial-depth core (left) ready for testing with DYNA

Drilling was accomplished with a Hilti core drilling machine using a 50-mm (2-in.) internal diameter bit (Figure 13). A 50-mm (2-in.) diam, 25-mm (1-in.) thick steel disc was secured to the surface of the core with a two-component epoxy adhesive. A Hilti HIT C-100 adhesive cartridge with a hand dispenser was used. The test disc was then pulled off with the DYNA pull-off tester (Figure 14).

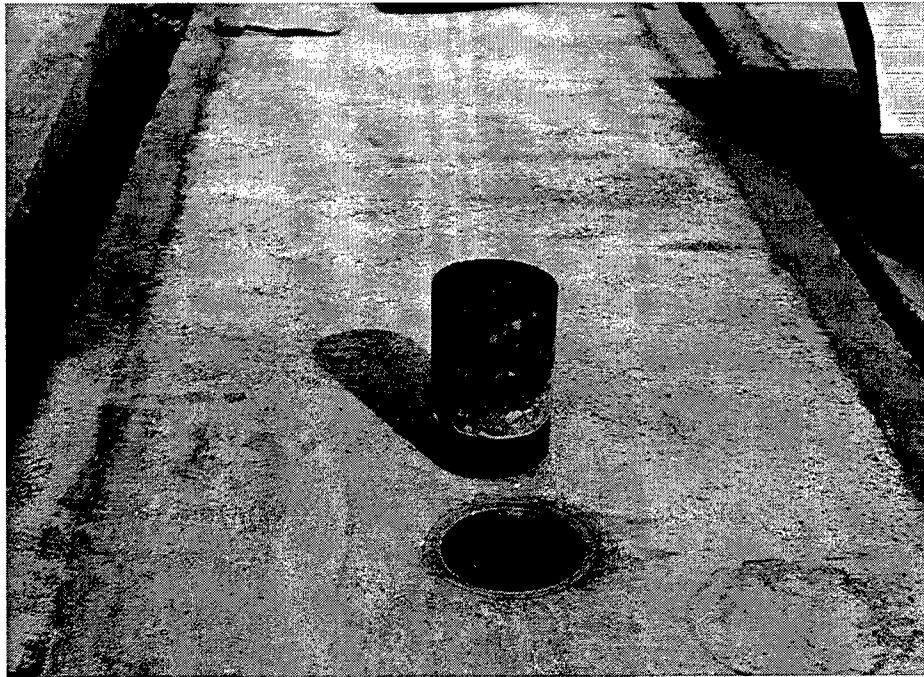
Figure 21. Failure at repair-substrate interface

The average test results for each material, mode of failure for each specimen, and standard deviation and coefficient of variation (COV) between the three pull-off tests for the same material performed by each testing device are presented in Tables 2-10. Examples of different modes of failure are shown in Figures 21-24.

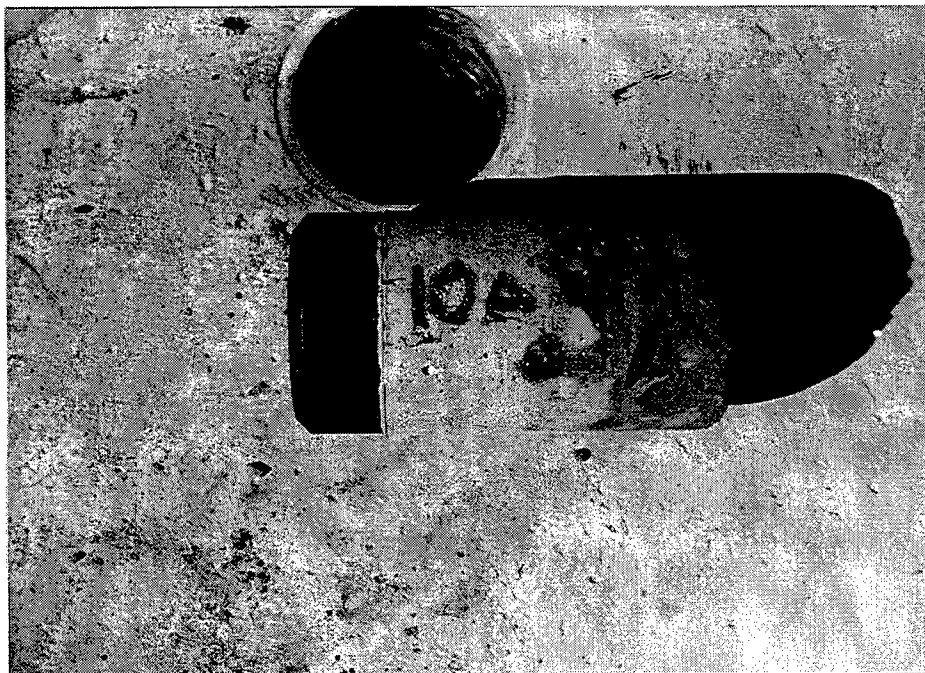
Figure 22. Failure in substrate concrete
